General Inspection

NAPA AUTOPRO - Kirkham Automotive Ltd

2007 Honda Odyssey

RO#: 39609

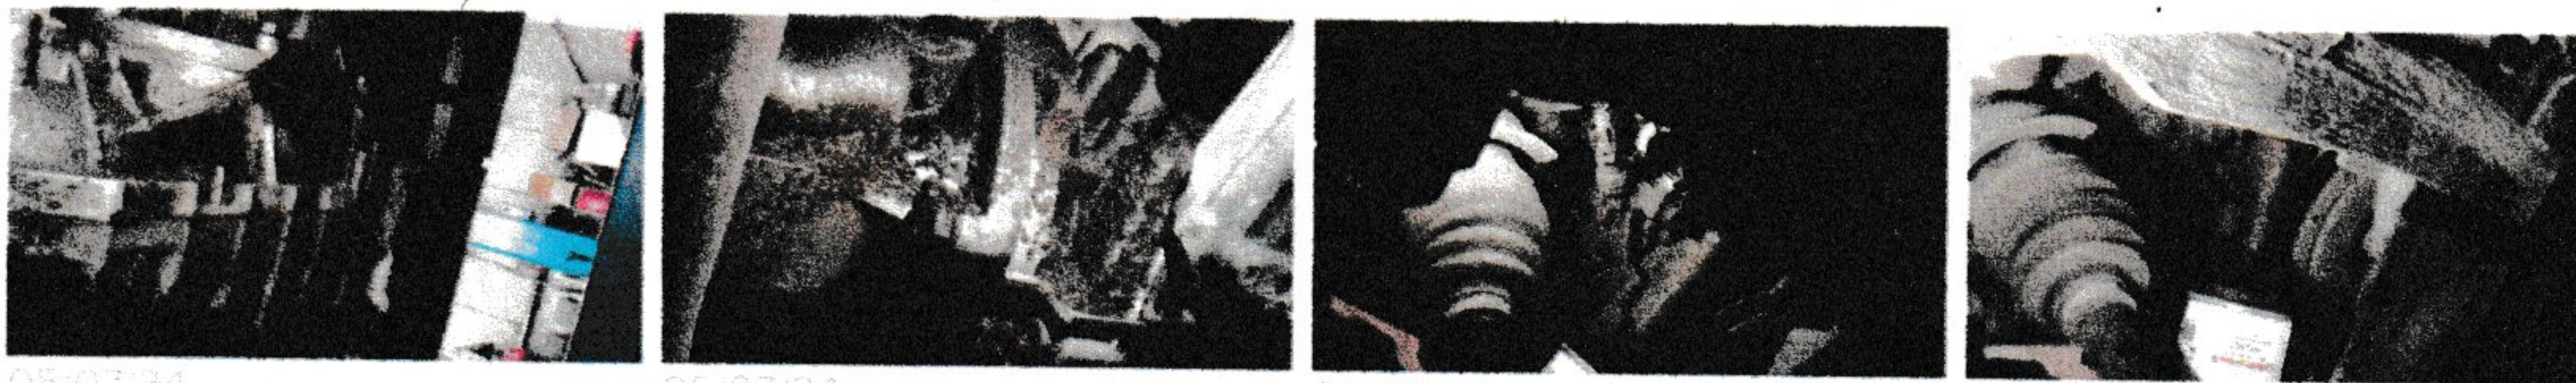
Rear main seal seeping.
Seeping on top near oil filter housing

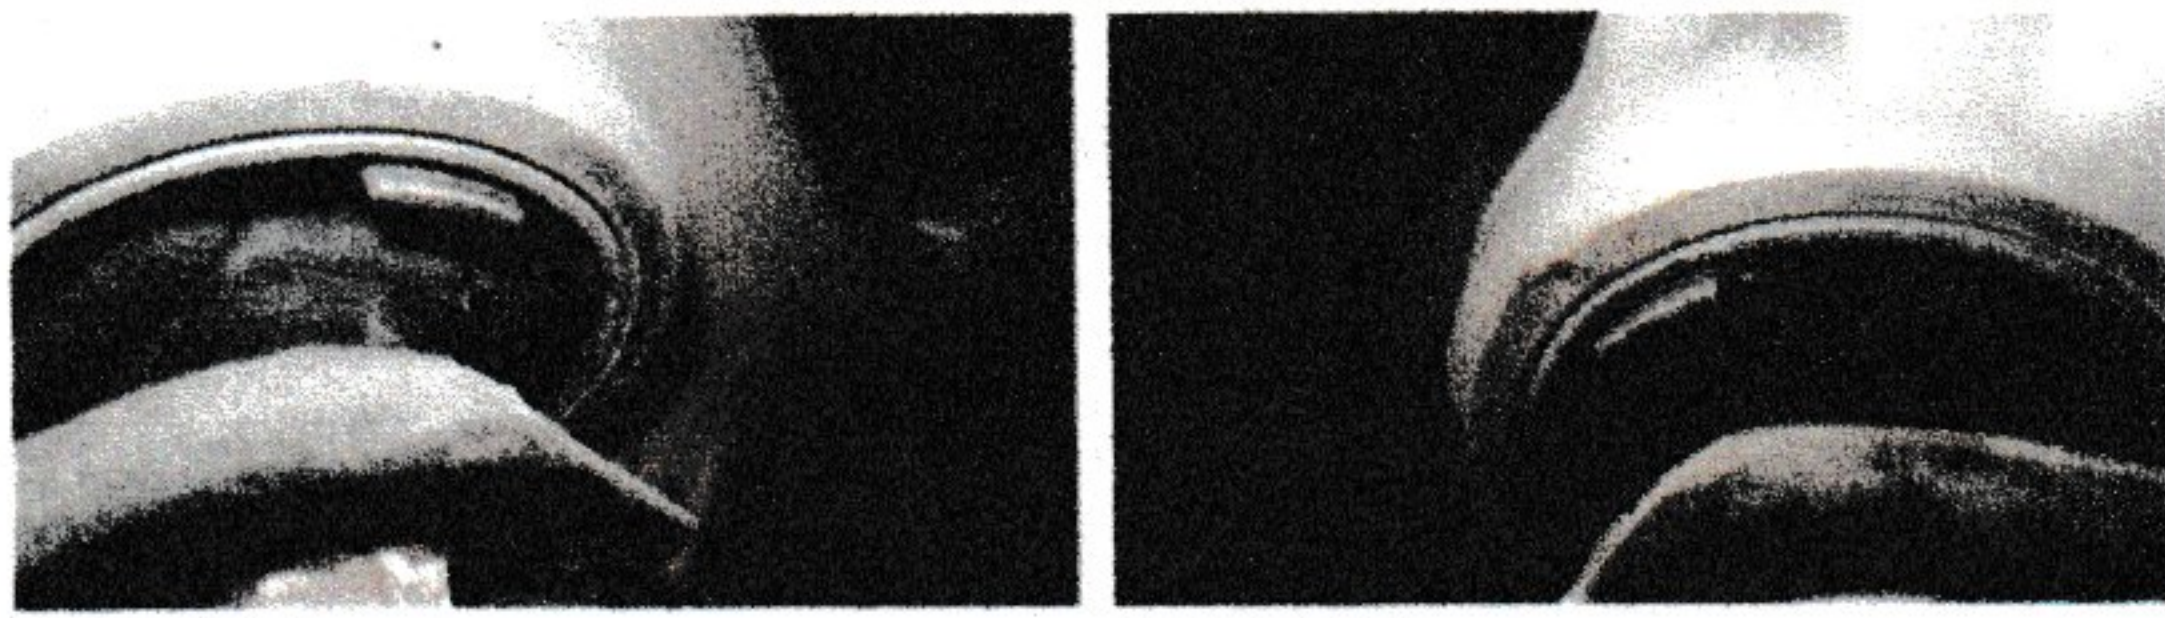
Front lower control arm bushings cracked
